USB 400x Video Inspection Probe

Product Introduction

April 2016

Anritsu Corporation

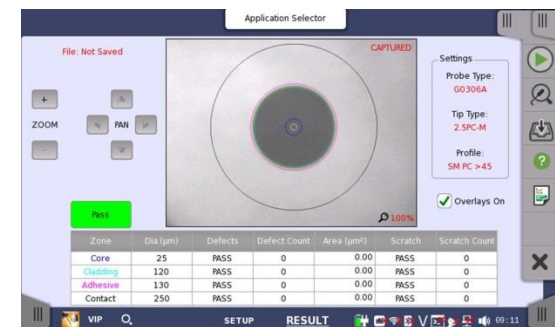
The G0306B can be connected to an MT1000A/MT1100A Network Master Series, MT9083x2 Series ACCESS Master, MT9090A Network Master Series (μ OTDR module) and PC, to show the state of a ferrule endface.

This function is effective for determining whether a ferrule endface is clean, and whether connector replacement is necessary due to connector scratches.

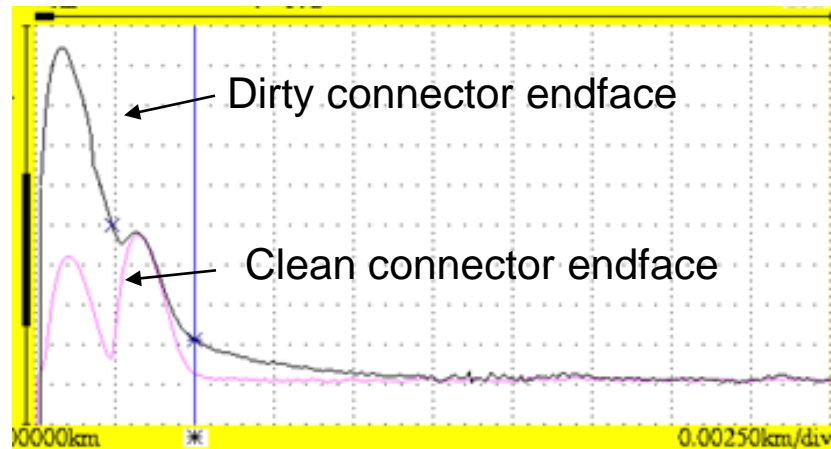
When a connector endface is dirty, it tends to produce a greater amount of reflection.

A good connection can be maintained by cleaning connector endfaces.

Optic Fiber Clad

Oil, Dust

Verification through OTDR Output Port Connection

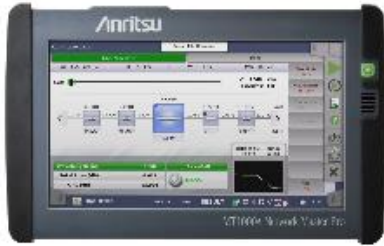
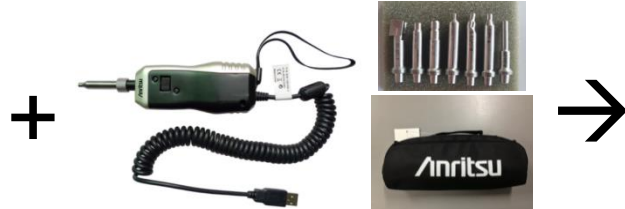
●MT1000A/MT1100A Series

*Include Pass/Fail analysis function
(Software version 1.00 or later)*

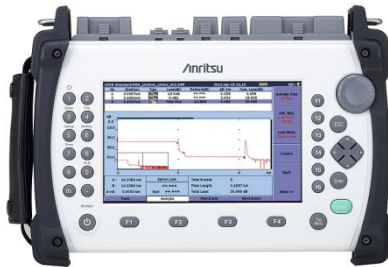
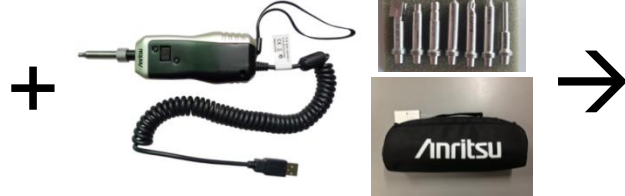
●MT9083x2 Series ACCESS Master

*Include Pass/Fail analysis function
(Software version 2.02 or later)*

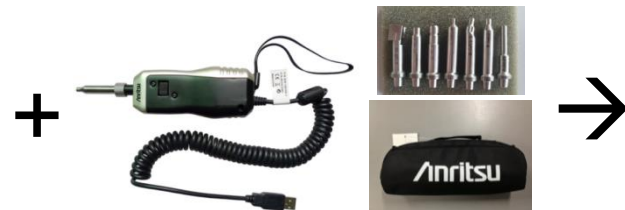
●MT9090A Series Network Master

µOTDR: MU909014/15

*Include Pass/Fail analysis function
(Software version 2.27 or later)*

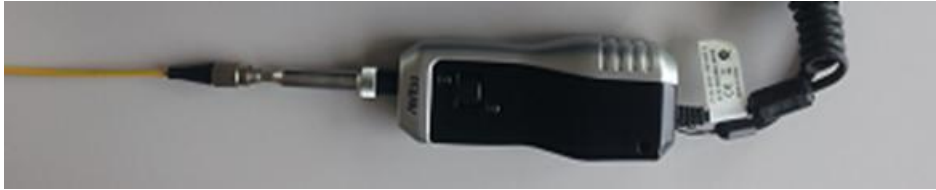
G0306B Accessories

Tips are connected to the end of the VIP based on the shape of connector (adapter) to be connected. This unit comes standard with 7 types of tips.

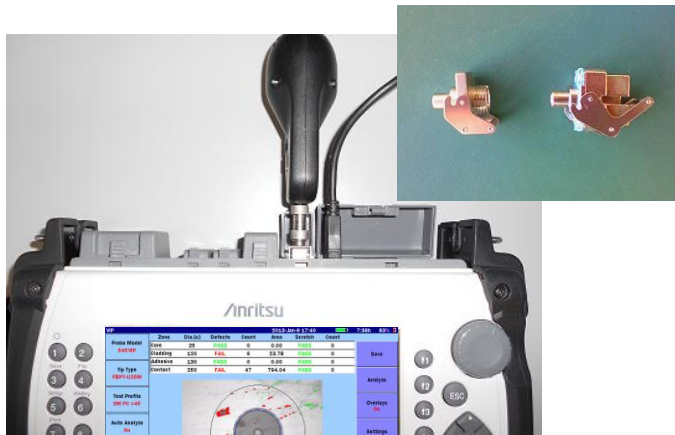
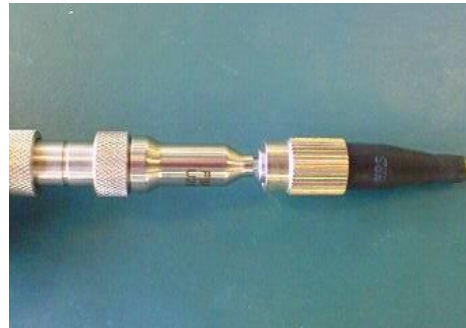
●Tips for universal type

As this figure shows, the universal type tip can be used to directly plug into the ferrule for test.

Connected to OTDR output port ferrule endface

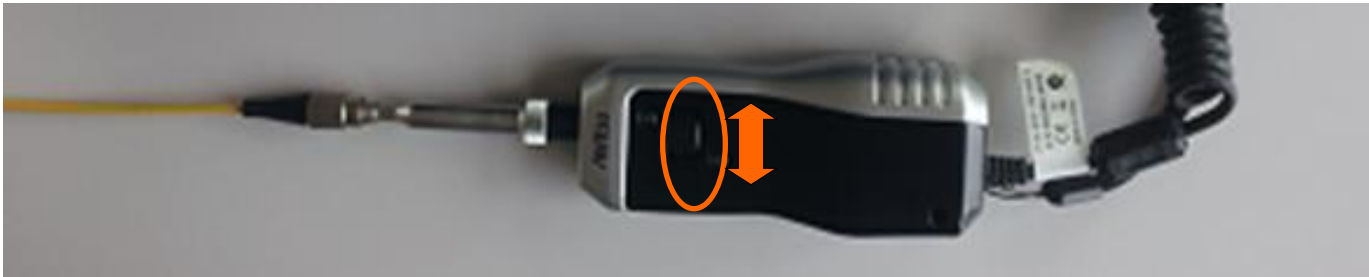
Basic Video Inspection Probe Operation

Fixed 400x focus

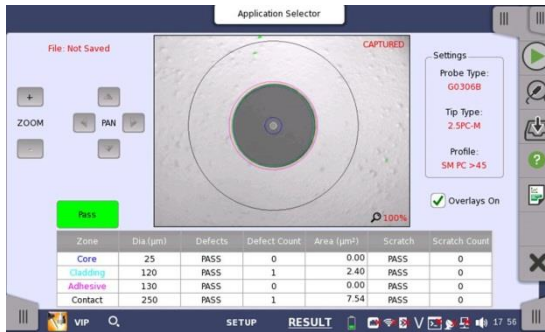
Adjust the focus in the Live screen, and press the Start button to begin analysis.

When analysis completes, the following information appears:

- Core
- Cladding
- Adhesive
- Contact

As well as a pass/fail determination for the total area for each.

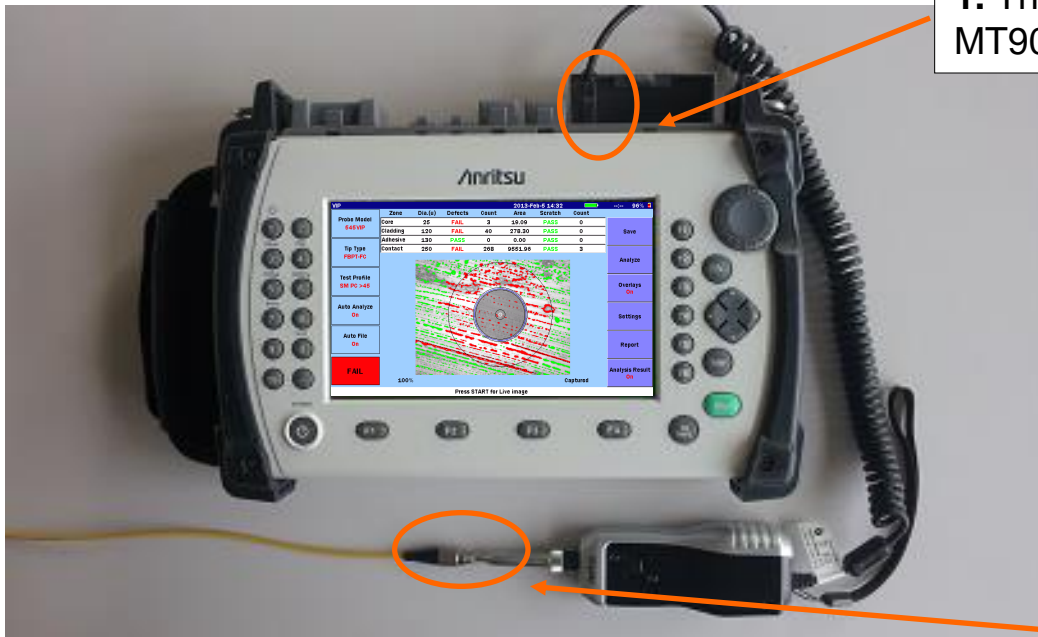
1. The VIP USB terminal is connected to the MT9083x2 series instrument's USB port.

2. The power is turned on.
"Video Inspection Probe" is selected from the top menu.

*Before starting, select the appropriate tip for the connector adapter and ferrule type to be connected to.

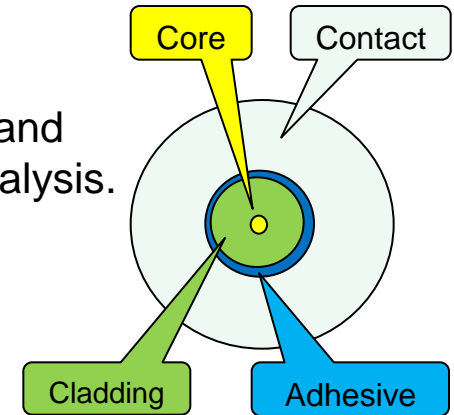
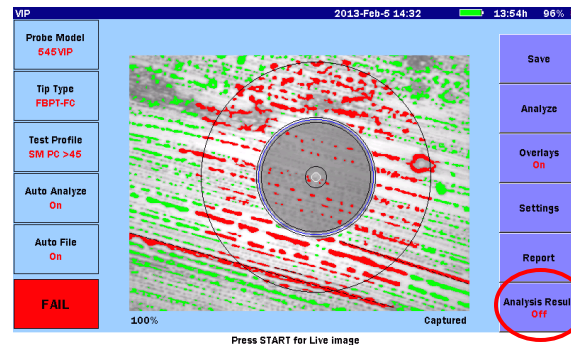
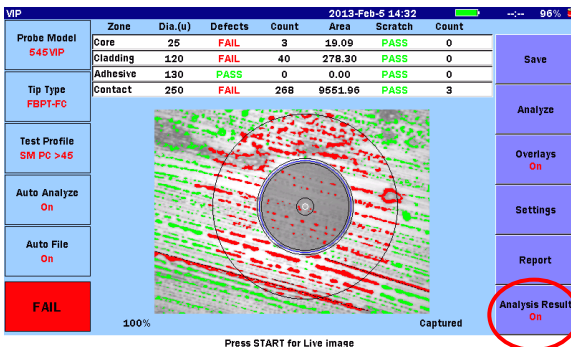
Adjust the focus in the Live screen, and press the Start

When analysis completes, the following information appears:

- Core
- Cladding
- Adhesive
- Contact

As well as a pass/fail determination for the total area for each.

Press f6 to toggle between Details (Table) and Image View.

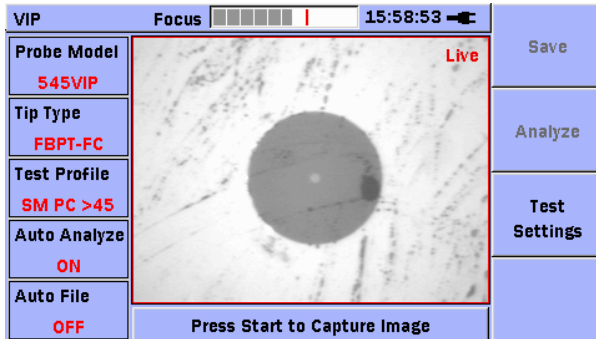
Measurement Sequence

Adjust the focus in the Live screen, and press the Start

As well as a pass/fail determination for the total area for each.

Zone Name	Diameter (μ)	Result
1 Core	25	PASS
2 Cladding	120	FAIL
3 Adhesive	130	PASS
4 Contact	250	FAIL
